## **EXHIBIT G**

**Investigation of the  
December 20, 2002  
Fire at The  
Marino Carriage House**

BN62867-A0T0-0306-R004

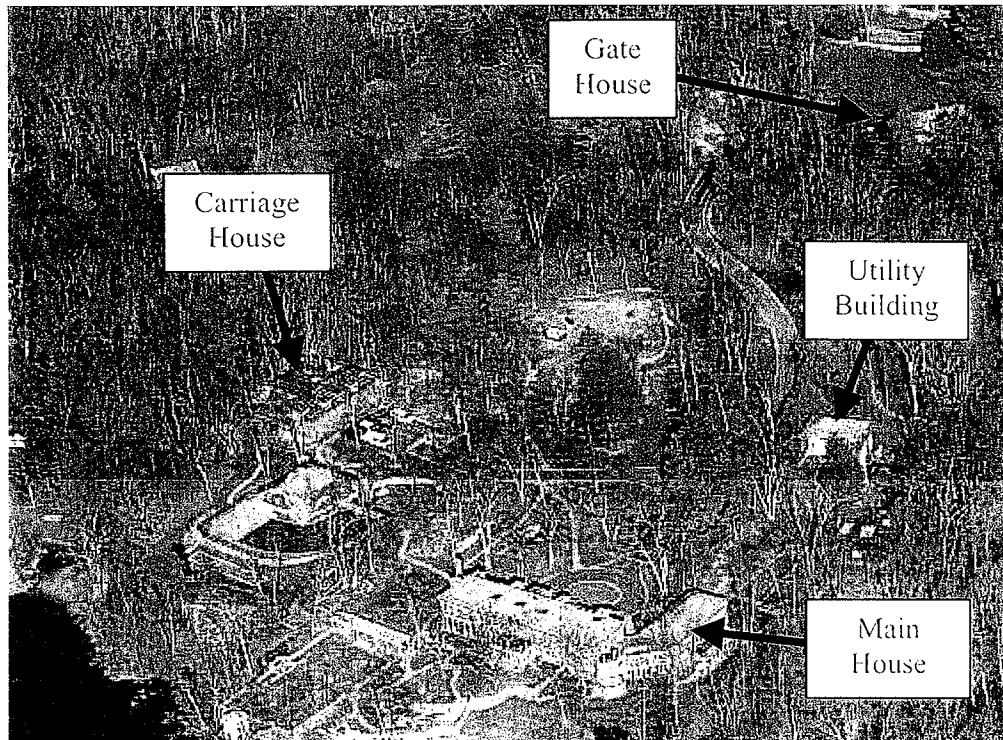
Figure 1: Aerial photograph of Marino complex during renovations to the carriage house

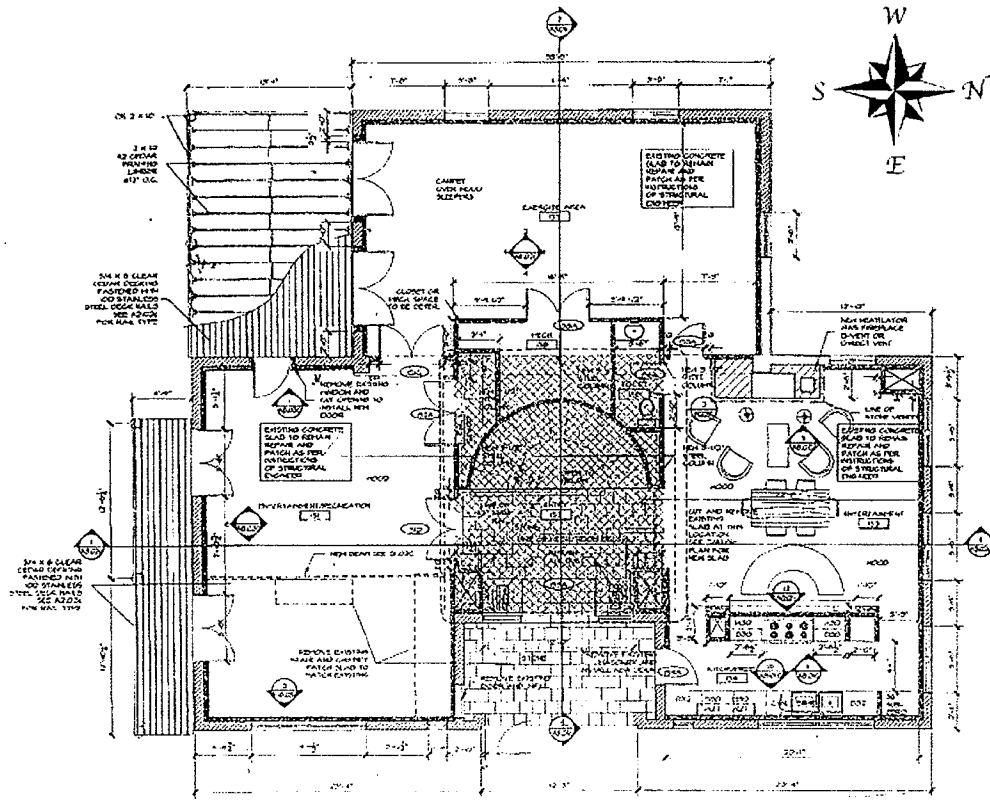
Figure 2: Plan view of first floor of building. The kitchen is located in the bottom right corner of the figure. The north side of the building is to the right of the figure.

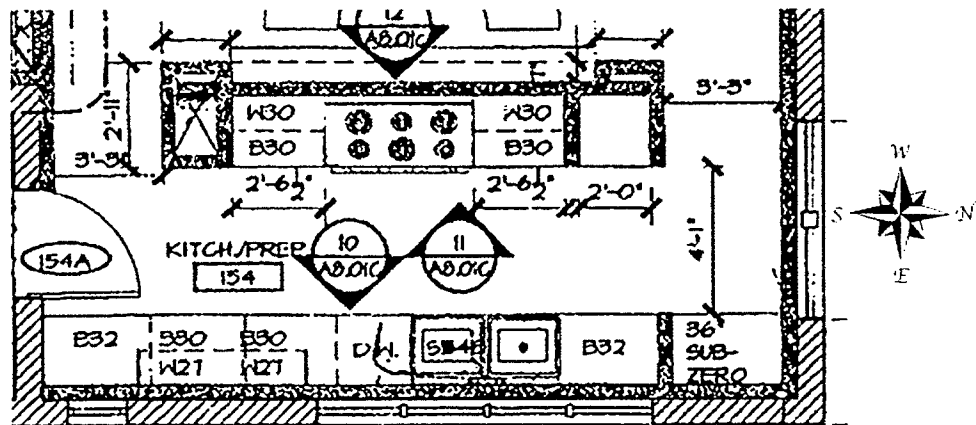
In his July 29, 2005 report, Mr. Thomas Klem alleges that the fire began underneath the kitchen sink which was located below the center of the kitchen window on the front (east) wall of the carriage house. The portion of Figure 2 corresponding to the kitchen is enlarged in Figure 15 to show this area in greater detail.

Figure 15: Enlargement of kitchen area of first floor from bottom right hand corner of Figure 2. Kitchen sink is centered in front of the large kitchen window located on the east wall of the carriage house. The installed kitchen sink was a single basin sink, contrary to what is shown in the drawing.
